Recreational Residence Aquatic Resource Assessment

Zigzag Ranger District
Mt. Hood National Forest

Duane Bishop and Todd Parker
February 23, 2009

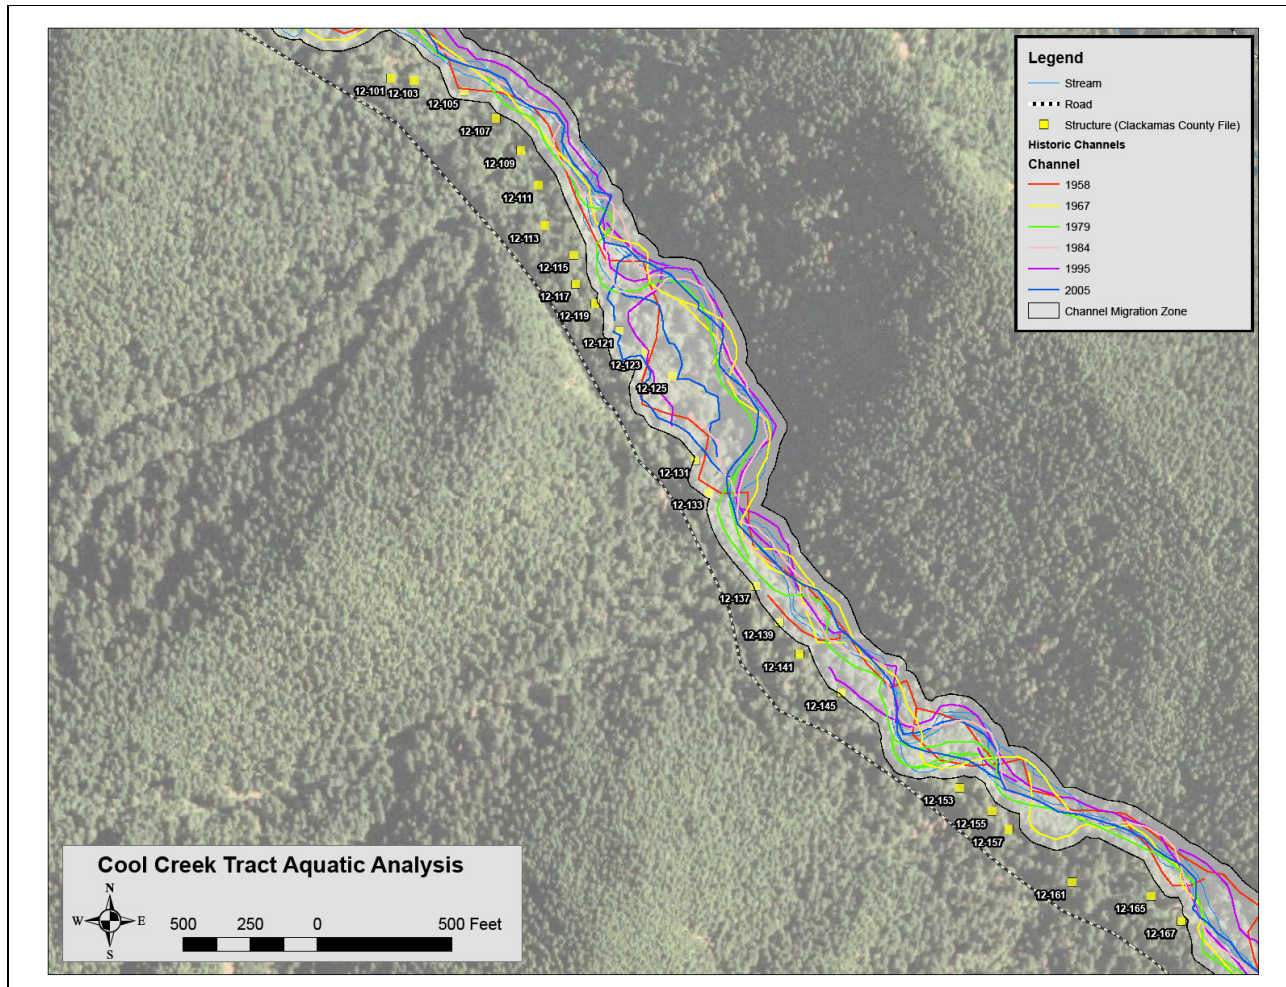
Figure 9. Channel migration zone for Still Creek from 1958 to present, within the Cool Creek Tract.

Aerial photos of the Cool Creek Tract from 1958, 1967, 1979, 1984, 1995 and 2005 were used to display channel position over time. Each photo was scanned and matched to the base image in GIS. The Still Creek channel centerline in each photo was delineated. Channel boundaries were not identified because they were not visible over the entire length of study area and some photos had moderate distortion at the edges, thus skewing the alignment. Any side channels that were apparent on the photos were also delineated. Geo-reference photos were overlaid on the 2005 ArcGIS National Agriculture Imagery Program image and plotted to display the centerline of the channel since 1958. Risk (low, medium or high) of channel migration was assessed. Once the channel centerline was established on each photo, 40 lineal feet was added to each side to graphically depict the bankfull width (USDA 1995). It is believed this represents a conservative estimate of the actual area wetted with bankfull flows (Figure 9). The channel migration zone dimensions were not modified due to roughness elements such as large trees, bedrock or other rock outcropping.

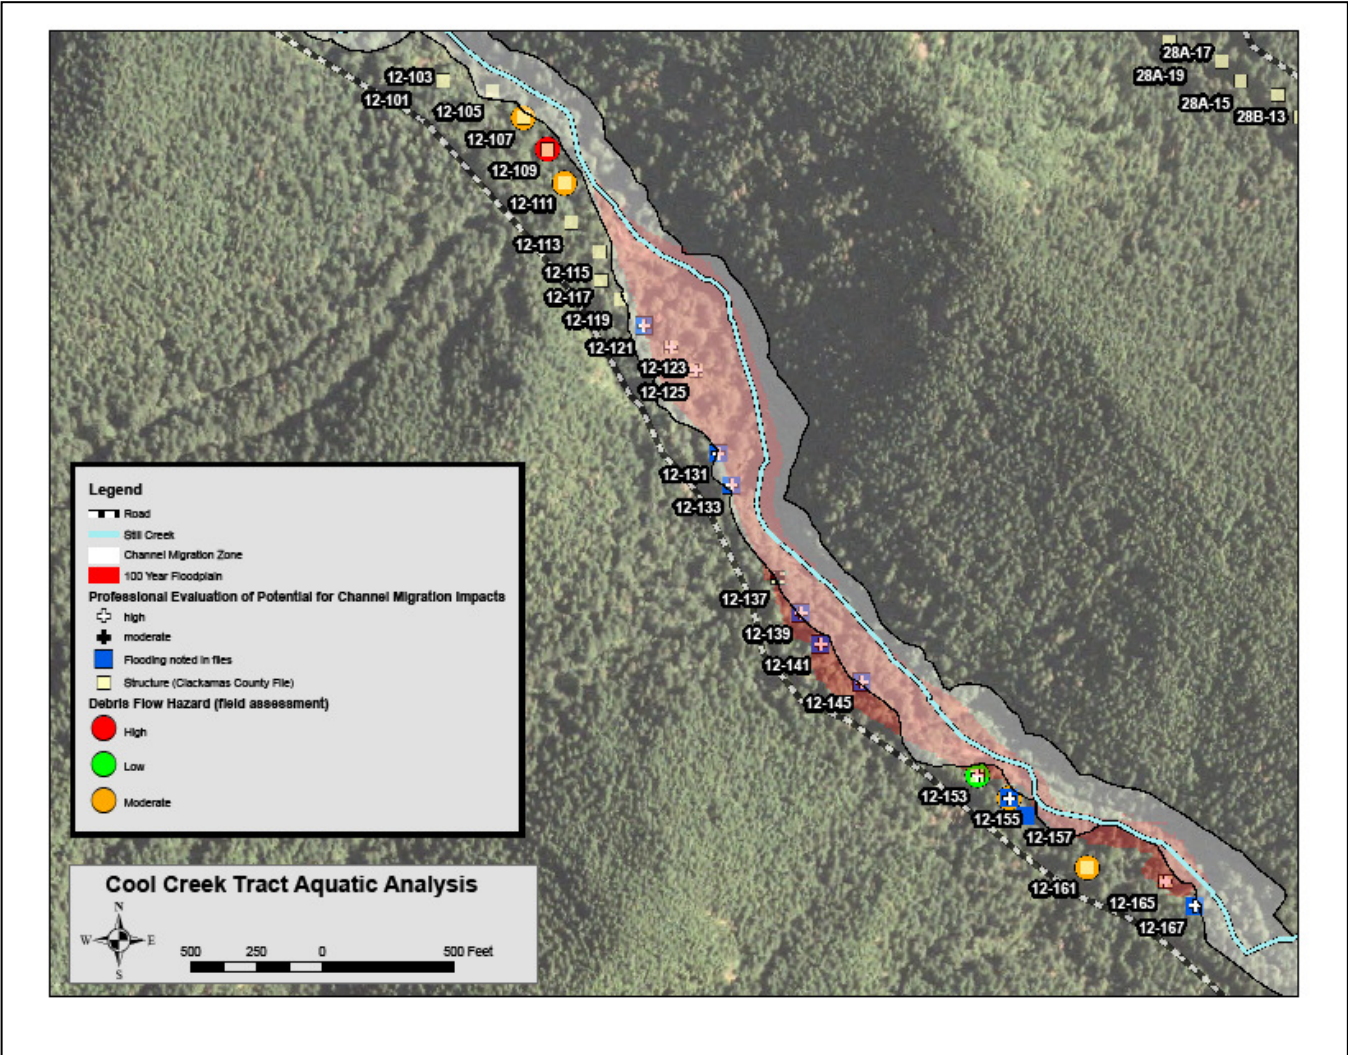
Figure 11, integrated map with professional evaluation of channel migration.

In order to integrate and synthesize the analysis, a professional evaluation of channel migration with the potential impacts to recreational residences was included (Figure 11). This evaluation integrated results from previous analyses and factors in interactions between processes to come to conclusions. This analysis was completed in coordination with NOAA Fisheries personnel.

The next step in the HF analysis was an assessment of each of the remaining 15 lots to determine if adverse effects or hazards could be mitigated without moving those structures. Of the 15 lots outlined in Table 4, only lot 161 fit these criteria. Currently the cabin is located on the terrace above the floodplain of Still Creek, adjacent to an intermittent tributary. This tributary was one that was analyzed in the debris flow hazard rating (see Figure 10). Because of its location, cabin 161 is at moderate risk of damage due debris flows from the tributary.

In summary, of the 15 lots identified in Table 4, 13 lots are at moderate or high risk of damage due to natural fluvial processes of channel migration, LW and sediment routing in Still Creek or debris flows from intermittent tributaries from Hunchback Mountain. Additionally, the presence of these structures is likely having negative effects to these processes as well, which include: limiting access to floodplains and side channels through the construction and maintenance of artificial berms, removal of LW and simplification of stand structure and composition. Routing and deposition of organic and

inorganic material from tributaries causes channel migration and reactivation of side channels and is interrupted by roads, driveways and other infrastructure not allowing deposition in Still Creek.
